PERFORMANCE OF PRECAST CLADDING PANELS WITH ROCKING CONNECTIONS UNDER LATERAL CYCLIC LOADING

Keywords: precast structures; architectural cladding; rocking motion; connections; sealants

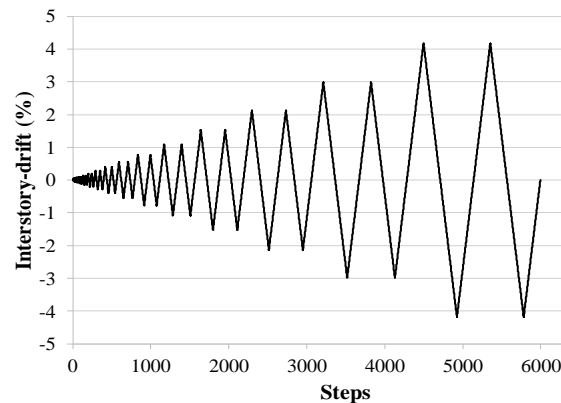
Fig. 4 – Loading protocol following FEMA-461[23]

A one-story 3D steel frame structure (Fig. 2) is designed and erected to test three different sub-assemblies of panel pairs: inclined-corner assembly, return-cover corner assembly and in-line assembly (Fig.2 and Fig. 3). The individual panel dimensions and their calculated/designed in-plane inter-story drift capacities are shown in Table 1. The connections at the base of the column and between columns and beams are hinged to allow a shear mode of deformation in the structure when the top slab is subjected to lateral quasi-static cyclic loading up to maximum inter-story drift of 4.18 % following FEMA 461 [23] loading protocol (Fig. 4). The bottom

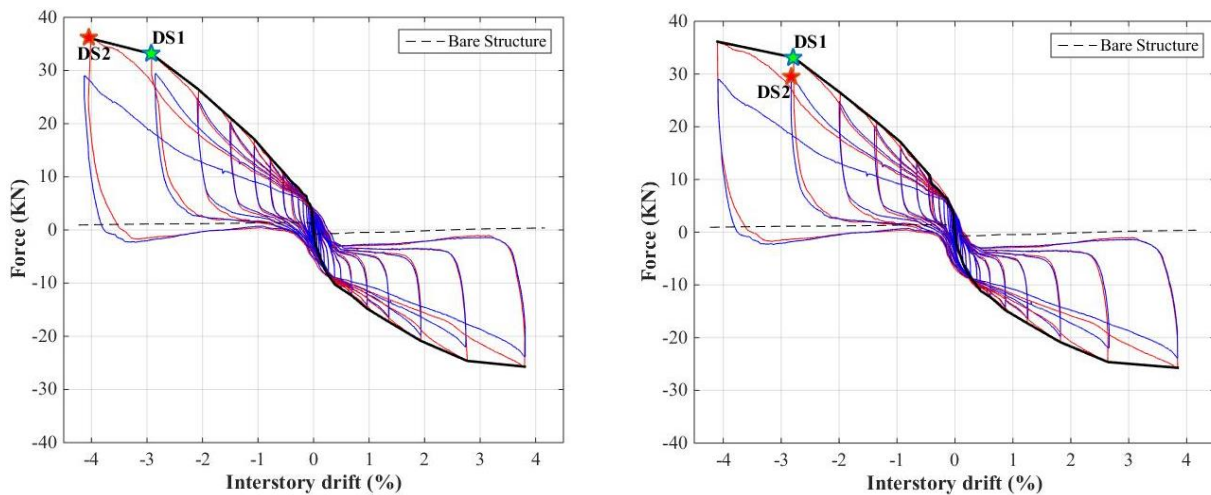
a. Frame A with return-corner sub-assembly

b. Frame B with in-line sub-assembly

Fig. 7 – Force-drift hysteresis loops showing onset drifts for damage states in the interposed sealants

The structure was subjected to lateral cyclic displacements at the center of the top slab. The top displacements in Frame A and Frame B were recorded by string-pot-2 and string-pot-1, respectively, (Fig.2). The force-drift hysteresis loops for Frames A and B are shown in Fig. 7. Note that the corresponding forces shown in Fig.7 are of the entire structure, not for a particular frame. These recordings show that the structural connections in the frame have some slackness which is clearly distinct while pulling the structure (positive drift cycles). The loading first starts (in the negative direction) with some initial stiffness due to shearing resistance provided by the interposed sealant. Under small lateral forces applied to the top connections of the panel, the panels are expected to behave as integral elements with the structure as they are equilibrated by the

After this limit is overcome, the panels are expected to behave as isolated from the structure, allowing lateral floor movements without imparting significant stiffness to the structure. In any rotated position, a constant horizontal stabilizing force is provided by the bearing connection on which the panel is seated. However, additional stiffness is observed in the hysteresis loops (Fig.7) as the bolts in the bottom steel-embeds gradually get engaged with the sides of the slot generating frictional resistance [22]. This also can lead to slight torsion in the structure (a maximum twisting angle of about 0.015 radians between Frames A and B was observed in the test). Strength and stiffness degradation can be observed in the hysteresis loops

of the same drift cycle and consecutive drift cycles, respectively, due to relaxation and/or tearing of the sealant.

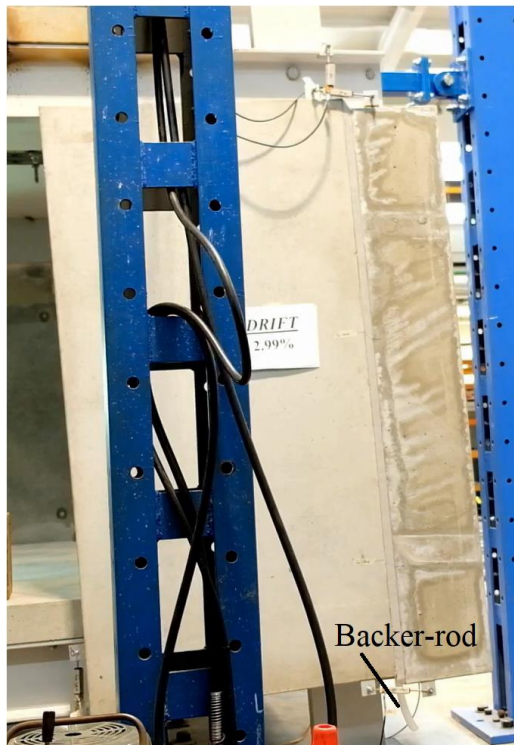
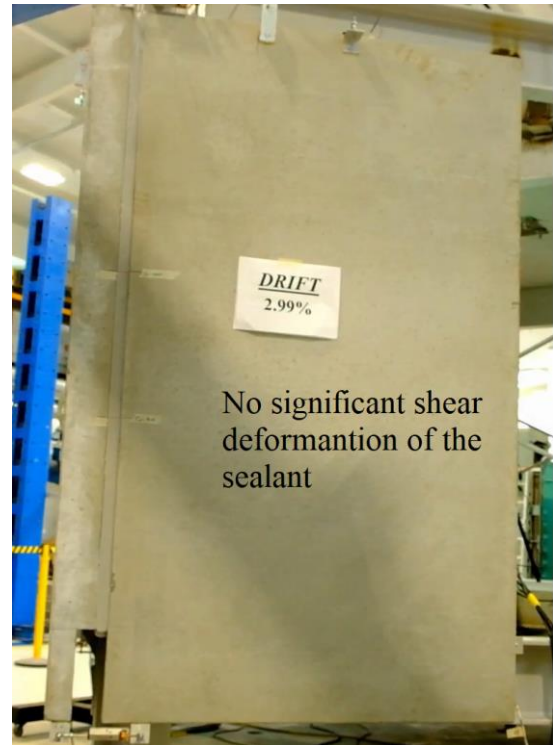
a. In-line sub-assembly

b. Return-cover corner sub-assembly

c. Front view of inclined-corner sub-assembly

d. Rear view of inclined-corner sub-assembly

Fig. 8 – Rocking of panels at peak of first -3% inter-story drift cycle

The panels exhibited rocking motion (Fig. 8) as expected under the lateral cyclic loadings. The bolt inside the vertical slot of the steel-embed slid ‘smoothly’, aided by grease, when the panels rocked as shown in Fig. 9. Visual observations during and after the testing showed no noticeable spalling or cracking of panels, no yielding of steel components and no loosening of the steel-embeds. The joint width was found to remain approximately constant throughout the test. However, significant shear deformation in sealants was observed in the joint interfaces (Fig.8.a and Fig.8.b) except in the joint interface of the inclined-corner sub-assembly (Fig.8.c), where panels CP1 and CP2 rocked without inducing significant differential vertical displacements at the joint.

sealant was found to be around 132%. Moreover, due to alternate rise and fall of the panels during their rocking motion, the backer-rod was observed to gradually slide downwards (Fig.8.a and Fig.8.b).
