Post-Earthquake Reparability of Buildings: The Role of Non-Structural Elements

Timothy John Sullivan

To cite this article: Timothy John Sullivan (2020) Post-Earthquake Reparability of Buildings: The Role of Non-Structural Elements, Structural Engineering International, 30:2, 217-223, DOI: [10.1080/10168664.2020.1724525](https://doi.org/10.1080/10168664.2020.1724525)

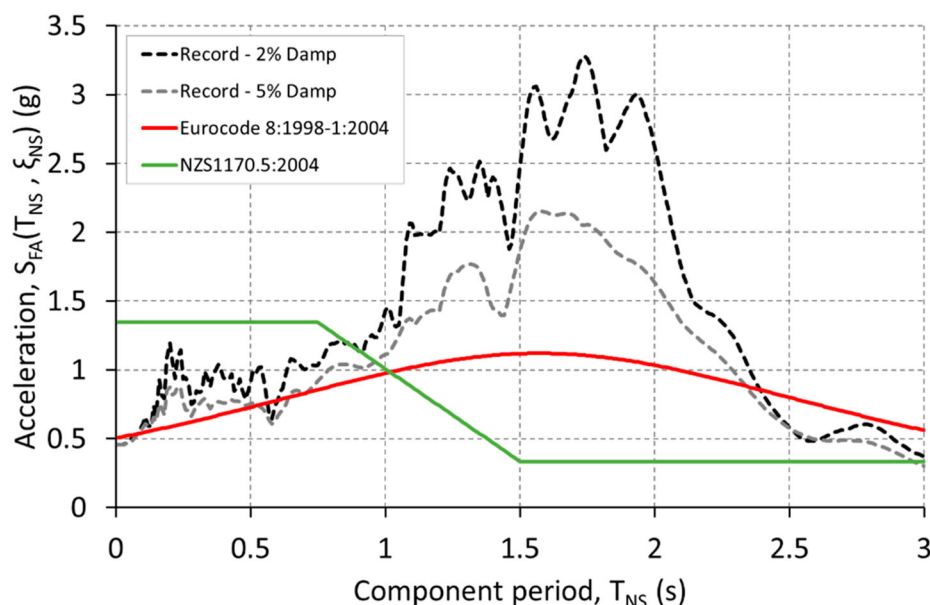
Fig. 5: Floor acceleration spectra recorded at roof level of an instrumented five-storey building during the 2016 Kaikoura earthquake compared with those predicted using standard code procedures

Work has been proceeding to quantify better the seismic demands on non-structural elements. This has mainly focused on the definition of floor response spectra, with literature¹⁹ showing that international codes all differ and are unable to provide reliable predictions of acceleration demands. *Figure 5* compares the roof-level response spectra recorded in an instrumented five-storey building in Wellington during the 2016 Kaikoura earthquake with code predictions using the same input ground accelerations. It can be seen that the international guidelines are not able to accurately predict the recorded acceleration demands. New guidelines are now emerging to provide more accurate floor response spectra. One of the important characteristics affecting the demands on non-structural

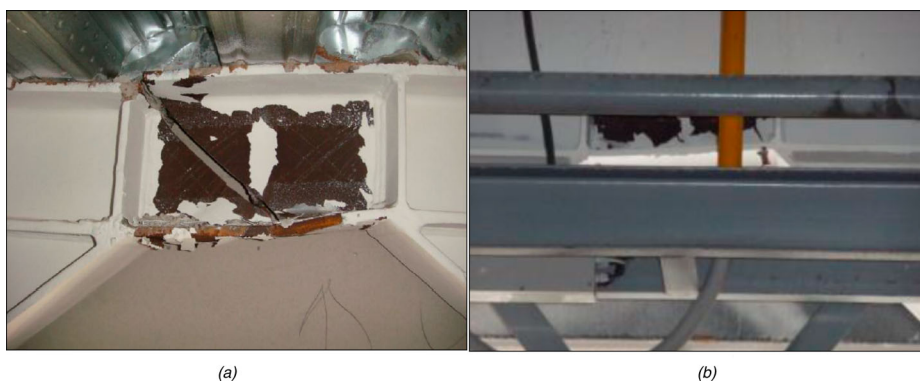
Fig. 6: (a) Fracture of an eccentrically braced frame (EBF) link at level 6 after the February 2011 event; (b) non-structural elements in the vicinity of a less damaged EBF link (From Clifton et al.²¹)

provide access for inspection and repair post-earthquake. A suitable repair strategy could be as simple as identifying where damage should be expected to occur in the structural system (i.e. identification of likely plastic hinge zones), recognising that these zones will require inspection post-earthquake. This process will increase recognition of the need to provide easy access to structural elements and highlight the need to consider the location of services relative to structural elements. Figure 6 shows damage to the links of steel eccentrically braced frame (EBF) structures observed in a 22-storey building during the Canterbury earthquakes.²¹ The links of a traditional EBF structure are intended to be damaged in rare intense earthquakes as part of the seismic

design philosophy. However, it is apparent from Fig. 6 that the positioning of non-structural elements (and, in particular, telecommunications and piping) in the vicinity of the links could significantly hamper repair works. In fact, the industry reported that to repair one link of the type shown in Fig. 6, approximately NZ \$20 000 was required just to remove and later reinstate the non-structural elements in the vicinity. Such expense could be avoided at the concept design stage if access for inspection and repair were considered as part of the concept design.

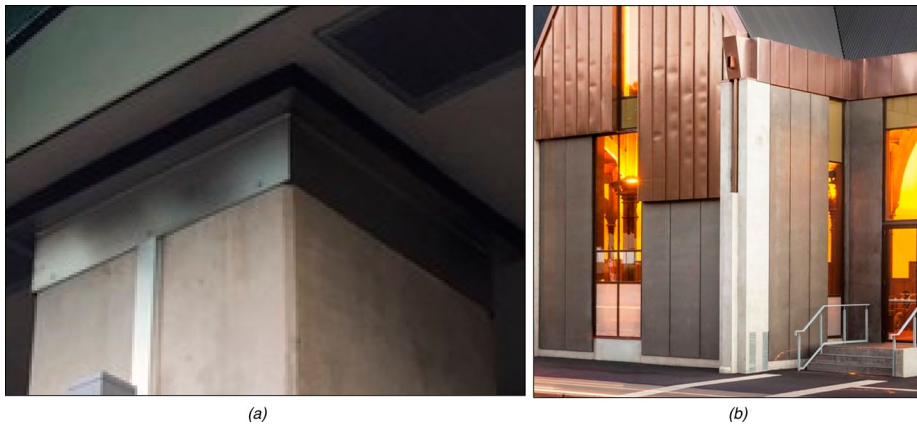
Fig. 7: (a) Removable stainless steel cover at the top of a column, encapsulating a base-isolation device; (b) removable stainless steel cover, screwed on four sides, to permit easy inspection of a rocking column base connection detail (Courtesy of Aurecon)

In the wake of such experiences, there are signs that the industry in New Zealand is indeed beginning to consider accessibility/reparability within new building design. Two examples of this from buildings in Christchurch, New Zealand, are shown in Fig. 7; in Fig. 7a one can see a removable stainless steel cover at the top of a column, encapsulating a base-isolation device, while in Fig. 7b a removable stainless steel cover, screwed on four sides, permits easy inspection of a rocking column base connection detail in Knox Church. In such structures, the post-earthquake inspection can be carried out without costly damage to non-structural elements and, therefore, these are examples of buildings with enhanced reparability.
