# EXPERIMENTAL STUDY OF THE SEISMIC PERFORMANCE OF PLASTERBOARD PARTITION WALLS WITH SEISMIC GAPS

Joshua G. Mulligan<sup>1</sup>, Timothy J. Sullivan<sup>2</sup> and Rajesh P. Dhakal<sup>3</sup>

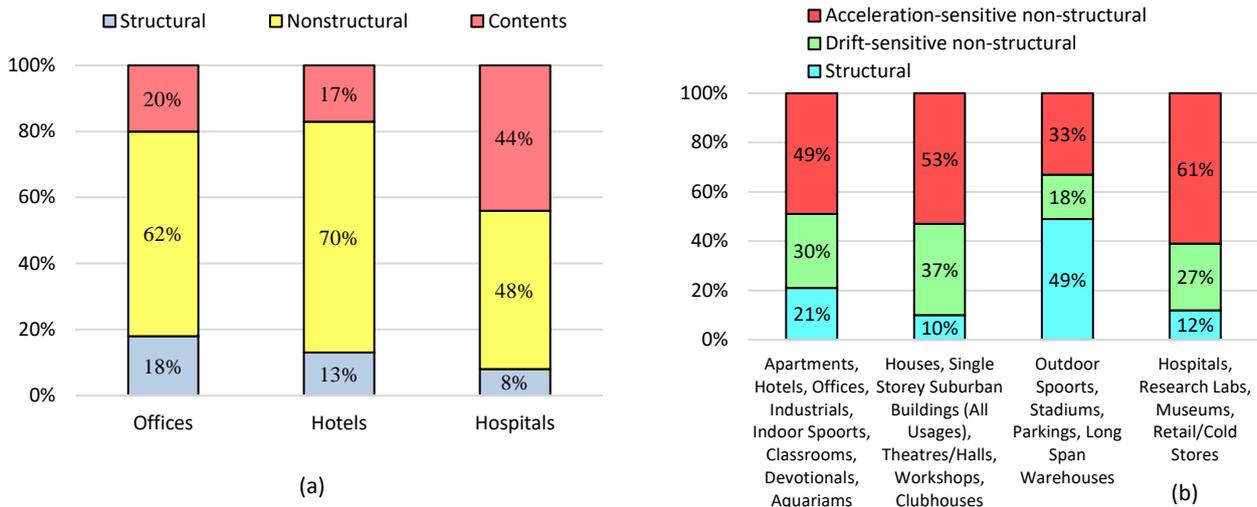
Figure 1: Building construction cost distribution of different buildings from (a) Taghavi and Miranda [1] and (b) Khakurel *et al.* [2].

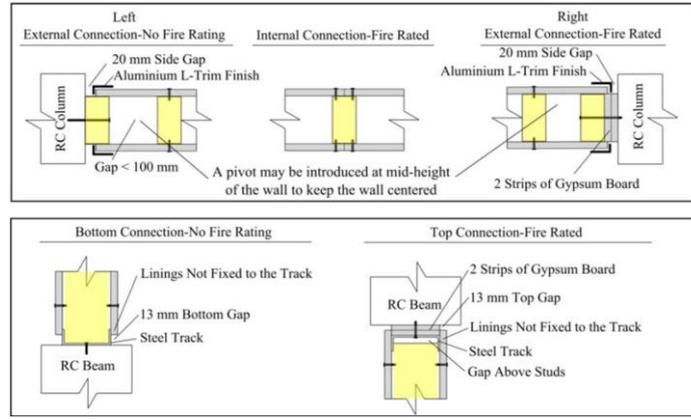
Figure 2: Details of low damage timber or steel framed specimens from Tasligedik et al. [20].

The seismic gap specimen details suggested by Tasligedik *et al.* [20] included fire and non-fire rated alternatives. These details are as shown in Figure 2. At the horizontal boundary the external studs were attached to the frame but not to the linings; and an additional stud was provided near the external stud to which the linings were attached so that the linings and internal framing are free to slide within the bottom and top tracks. As the specimens tested in by Tasligedik *et al.* [20] did not include any specimens with return walls and displacements were applied in-plane only, these details have not been verified for their out-of-plane performance or considering the interaction with return walls. The objective of this study therefore is to investigate the behaviour of partition systems with seismic gaps in configurations that have not previously tested: as an internal

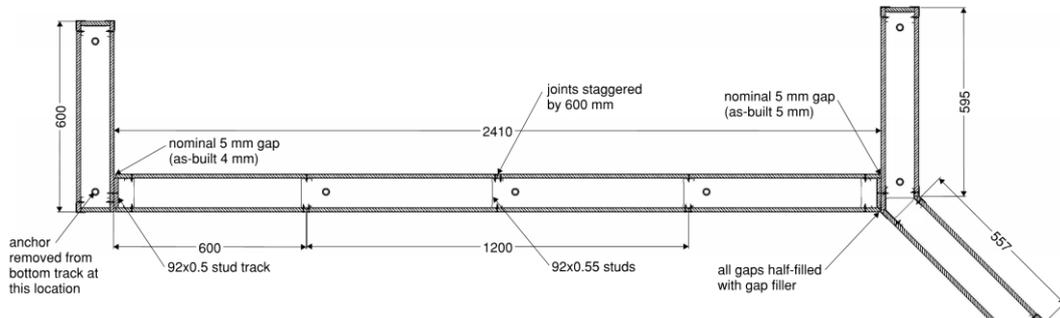
Figure 3: Specimen 1 plan - steel stud wall with no intermediate joints.

The configuration chosen to provide a baseline for the specimens was a fire rated partition typology selected from GIB Fire Rated Systems [23] with a 60 minute fire-resistance rating (GBS60). Two specimens were constructed: a steel stud specimen with a total nominal horizontal gap size of 10 mm provided by two nominal 5 mm gaps at each end (details shown Figures 3, 5, and 6); and a timber stud specimen with a total nominal horizontal gap size of 25 mm provided by two nominal 10 mm gaps at each end and an additional nominal 5 mm gap in an intermediate joint (details shown in Figures 4, 5, and 6). The steel stud specimen framing consisted of 92 x 0.55 bmt studs, 92 x 0.5 bmt stud tracks, and 92 x 1.15 bmt deflection head tracks. The timber stud specimen's framing materials were identical however 90 x 45 timber studs were used instead of 92 x 0.55 bmt steel studs. For both specimens the framing was sheathed with 13 mm GIB Fyrelite® connected to the framing with 25 mm x 6 g GIB Drywall Self Tapping Screws® at 300 mm centres up each stud. Bottom and top tracks were fixed to the top and bottom floor slabs with HILTI HUS3-H 8 x 55 screw anchors at 600 mm centres and were left out at some locations as shown.

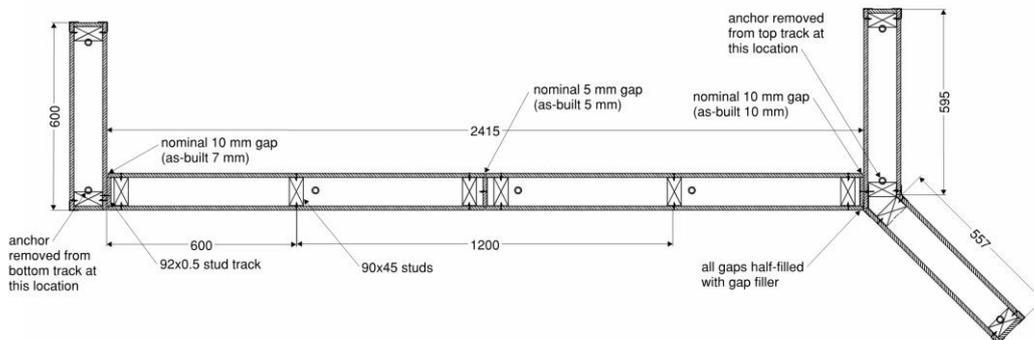
Figure 4: Specimen 2 plan - timber stud wall in steel tracks with intermediate joints.

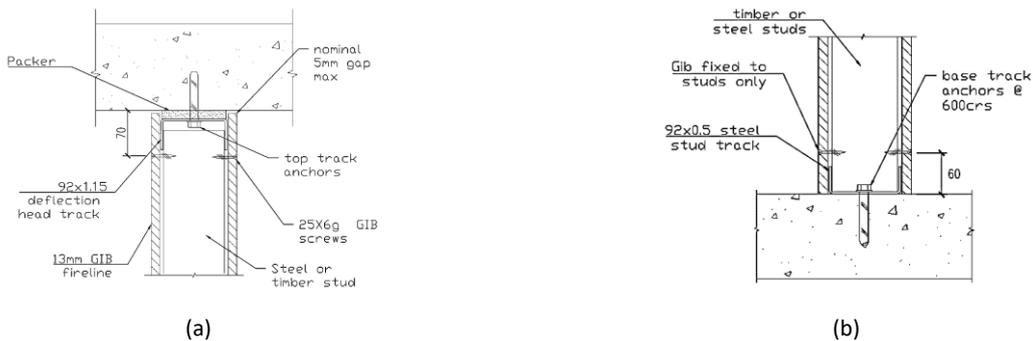
Figure 5: (a) Top slab to track connection (b) Bottom slab to track connection.

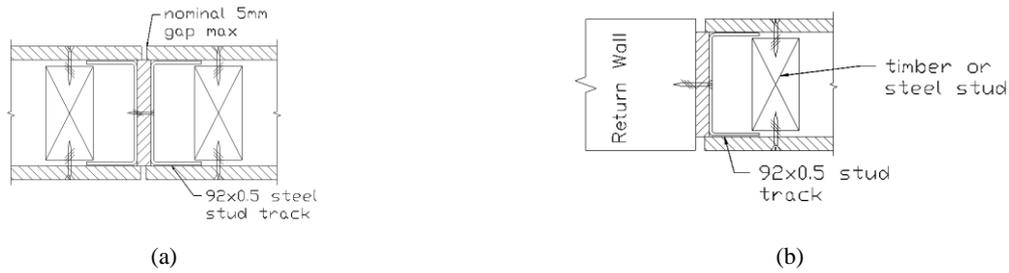
Figure 6: Details of modifications to Tasligedik et al. [20] low damage system (a) intermediate joint detail for Specimen 2 (b) Studs fit within steel tracks at junction for both specimens.

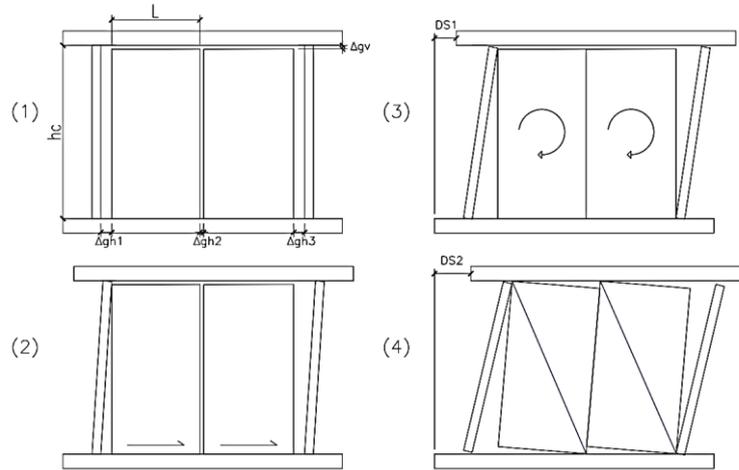
Figure 7: Predicted in-plane behaviour of specimens demonstrating estimated lower bound drift capacities for DS1 and DS2.

The in-plane behaviour of the specimens can be predicted assuming that the framing is free to slide within the tracks and that the linings behave as rigid bodies (Figure 7). The anticipated in-plane drift capacity for each specimen can be calculated from Equations 1 and 2 as per the deformation behaviour shown in Figure 7.

Where  $D_1$  and  $D_2$ , are the design lower bound interstorey drift capacity for the damage state 1 and 2 respectively,  $\Delta_{Gh}$  is the sum of the horizontal gaps along the wall,  $\Delta_{Gv}$  is the sum of the vertical gap along the wall between the linings and the top and bottom floors,  $h_c$  is the clear height between floors (2405 mm), and  $L$  is the largest length of panel between joints along the wall. As there is a vertical gap between the linings and floor slab, the linings are able to undergo an additional interstorey drift before a strut will form. It is expected that wallboard damage will take place after the drift calculated from Equation 2 is reached, acknowledging that some of this capacity may be used up by vertical floor deflections. If significant floor deflections are expected this should be accounted for by reducing  $\Delta_{Gv}$  accordingly. For specimen 2 the length of panel between joints is reduced due to the presence of an intermediate joint and so it is anticipated that this will increase the drift at which DS2 occurs relative to a wall with gaps only at the ends. The specified gap sizes varied slightly from the design drawings, highlighting the need to allow for construction tolerances. Only the design drift capacities calculated using the as-built dimensions are shown in Table 1.

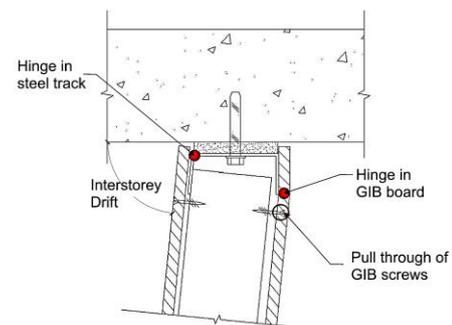
Figure 8: Predicted out-of-plane damage at large drift levels at the top and bottom interfaces.

As the plasterboard linings is not directly fixed to the steel tracks at the top or bottom, it is predicted that the plasterboard and internal framing will be free to rotate as the top boundary is displaced. As the mid-height of the wall is composite steel and gypsum board it will be significantly stiffer out-of-plane compared with the top and bottom ends of the wall. Therefore, it is anticipated that the gypsum board and the steel tracks will deform locally at the ends of the walls allowing the internal frame to rotate. The predicted large displacement behaviour of the wall is shown in Figure 8. The out-of-plane behaviour will

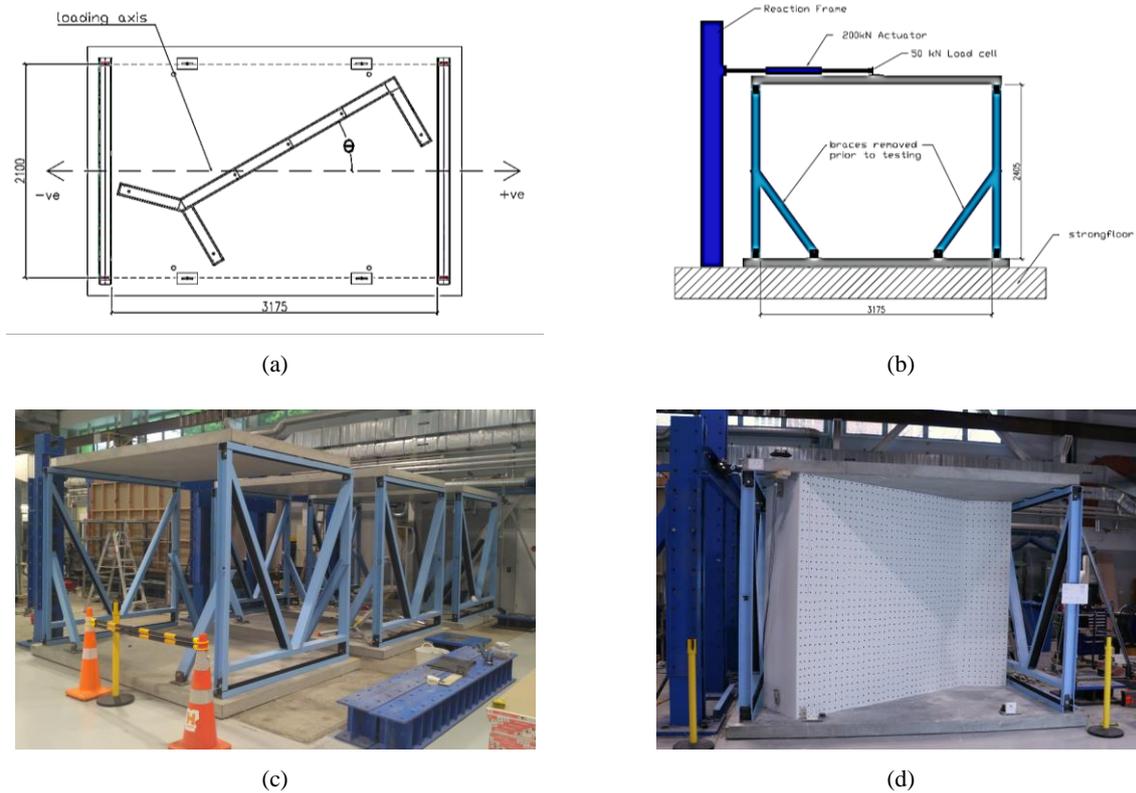
Figure 9: (a) Plan of testing frame (mm); (b) Elevation of testing frame (mm); (c) Photograph of setup; (d) Photograph of setup with specimen 1 installed.

The walls were tested in racking in order to simulate the seismic loading experienced by internal partition walls in commercial buildings. The testing support frames (Figure 9) were hinged at the top and the bottom in the direction of actuator movement, with diagonal braces to provide stability while the actuator was not attached. The frames were constructed of steel 125 PFC members. The top and bottom concrete boundaries were 120 mm thick reinforced concrete. This slab was selected in order to simulate the most typical boundary conditions and flooring systems in real buildings. The plan dimensions of concrete space available to construct the partitions was 3175 mm by 2100 mm, and the clear height was 2405 mm. The response of the bare frame (Figure 10) was approximately linear with a stiffness of 10.1 N/mm.

plane drift of 5.09% for walls angled at 35° (Figure 11). To assess the impact of bidirectional demands on fragility, the wall specimens were aligned at an angle of 35° to the loading direction, as shown in Figure 9a.

pattern of behaviour was that the load and displacement started at zero but thereafter the load was non-zero at zero displacement. This is due to inelastic behaviour. When loaded in the positive direction, the walls had less capacity in all cases. This asymmetric behaviour may be due to a couple of reasons: (1) The asymmetry of the specimens, and (2) bias in the loading; as the loading is first applied in the positive direction for each step the specimen will damage in the first cycle leaving less capacity in the specimen when the loading is reversed. However, as the positive direction had less capacity for both specimens, also under subsequent cycles to the same drift demand, the geometry of the specimen must have been the main factor producing this asymmetric response. The orientation of the specimen to the loading direction is as shown in Figure 9a, where  $\theta$  is  $35^\circ$ .

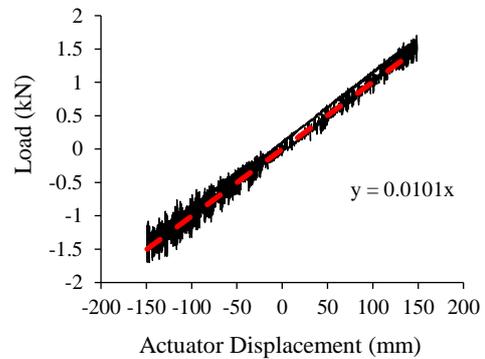
Figure 10: Load displacement behaviour of the bare frame.

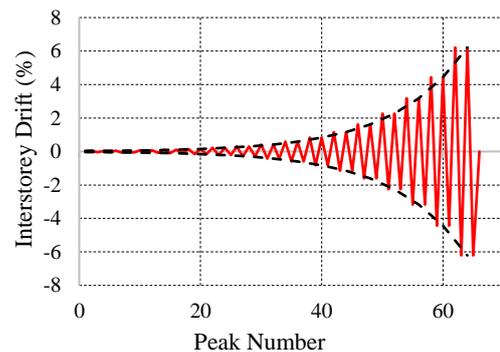
Figure 11: FEMA 461 quasi-static cyclic displacement protocol used in these tests.

A total of sixteen loading steps were performed, up to a magnitude of 6.21%, which corresponds to a maximum in-

Damage observations were taken after each step in the loading protocol (Figure 11) and these relied upon visual inspections, physical marking of observed damage, notes, and photographs.

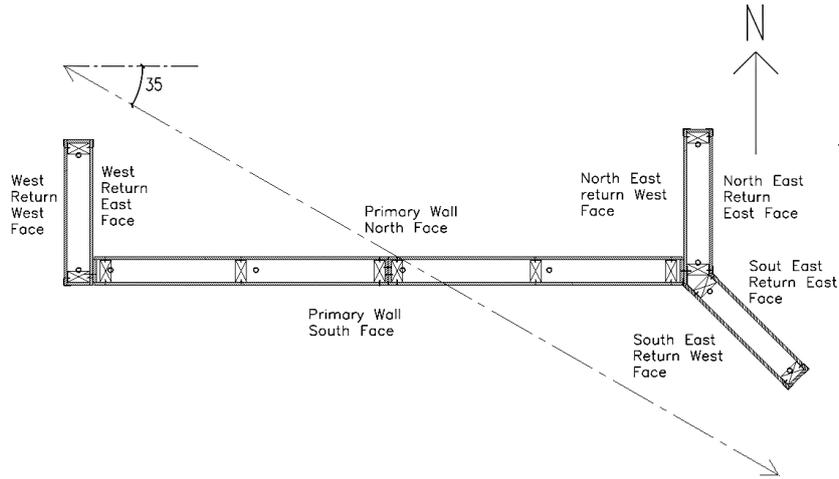
Figure 12: Wall specimen showing references for wall locations.

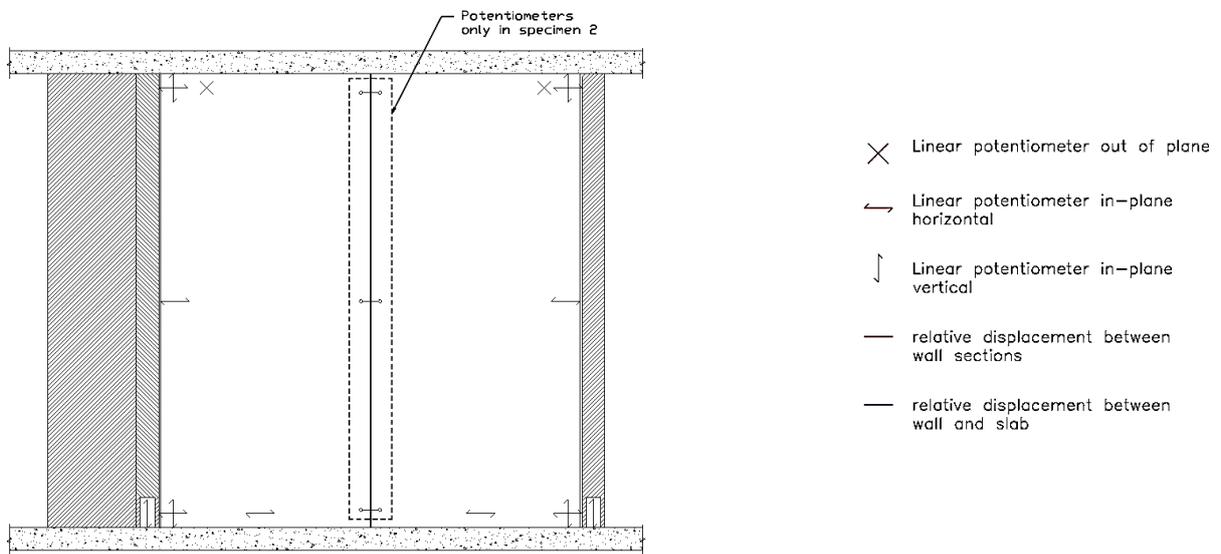
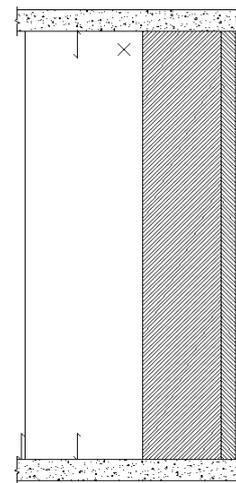
Figure 13: Potentiometer layout (a) primary wall north face (b) west return wall west face (c) north east return wall west face (d) south east return wall east face.

The load applied to the specimens was recorded from a 50 kN load cell with an accuracy of  $\pm 3$  N. The specimens were instrumented with a combination of linear potentiometers and a camera. Potentiometers were used to measure the horizontal, vertical and lateral deflections for both specimens. Specimen 1 used 26 potentiometers and specimen 2 used 29. The instrumentation layout is shown in Figure 13 with reference to the location shown in Figure 12. A series of high contrast points at approximately 75 mm spacing were applied to the surface of the specimens and the camera took pictures of these surfaces at each displacement increment in order to allow particle tracking analysis.

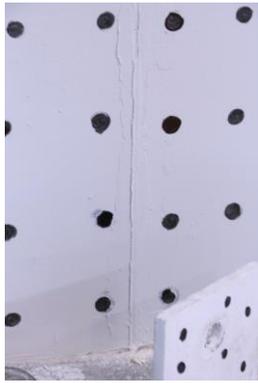
(a) Paint cracking

**Figure 14: Examples of specimen damage.**

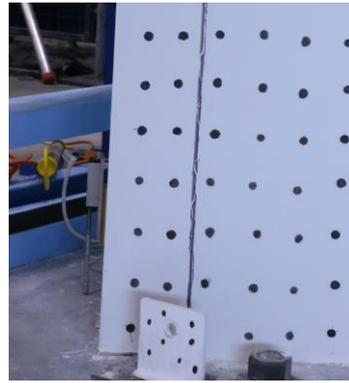
(b) Sealant de-bonding

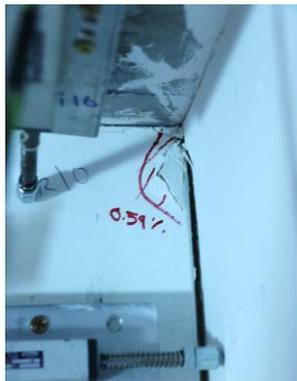
(c) Plaster cracking

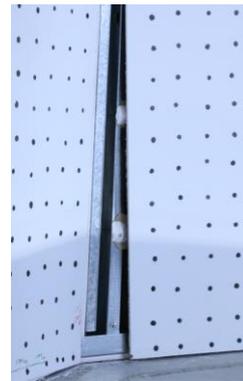
(d) Wallboard detaching

Very little screw connection damage (DS1c) was observed during the test, in particular no popping or pull-through of the fastener heads was observed. The only form of screw connection damage observed was seen during the final loading step of both tests, where at some locations the sheathing had detached from the studs (Figure 14d). This occurred primarily along the top and bottom of the boundary studs of the long wall.

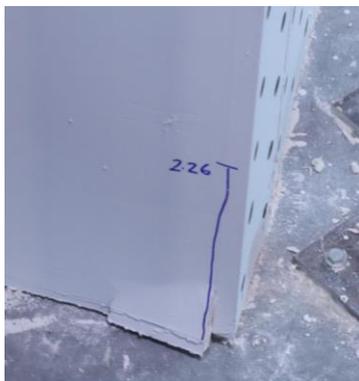
(e) Wallboard damage

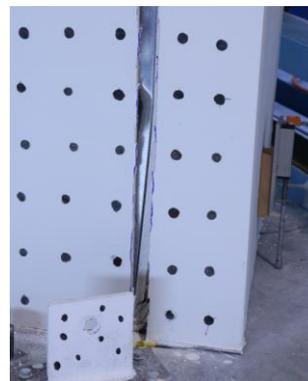
(f) Framing damage

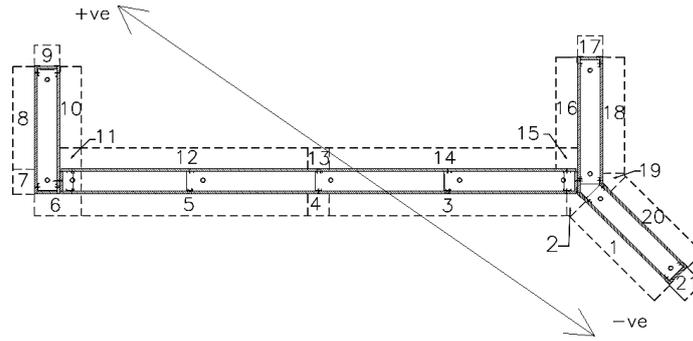
Figure 15: Reference locations for damage observations.

The damage progression for specimen 1 and 2 is shown in Table 5 and 6 respectively. In these tables the locations 1 to 21 shown in Figure 15 have been used when referring to damage. These locations refer to any vertical point within the area shown and represent the panels, joints between panels, and wall ends. The drift values shown in the tables refer to the in-plane drift along the different wall segments. In discussing damage progression below the in-plane drift along the long section of the wall has been used unless otherwise stated.

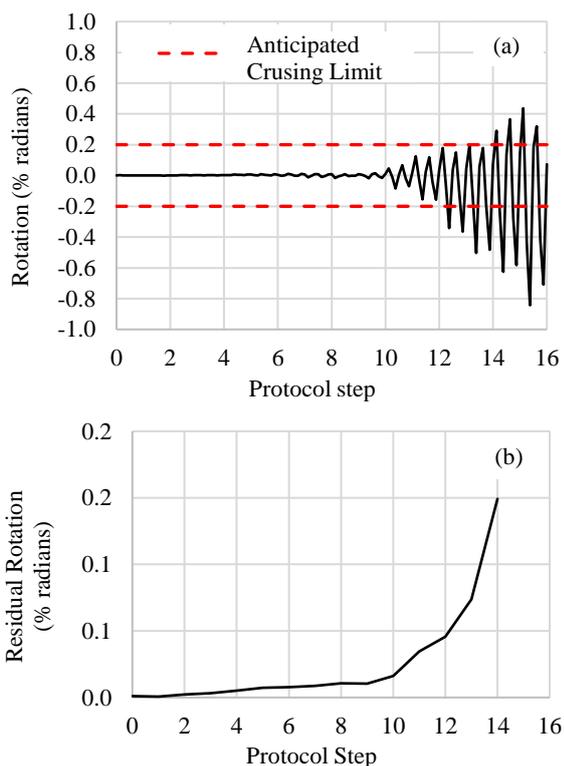
**Figure 16: Specimen 1 potentiometer readings to record rotation: (a) peak excursions during each step and (b) residual rotation after each step.**

The rotation of the main wall section was recorded throughout the test. As the gap between the lining and the top floor was ~5 mm, the expected maximum rotation of the linings before crushing occurs could be estimated as  $(5 \text{ mm} / 2410 \text{ mm}) \times 100\%$ , which corresponds to 0.21% radians. Figure 16a shows that for specimen 1 crushing of the linings should begin at step 11, at which the rotation is a maximum of 0.16% radians. This was confirmed as plasterboard crushing was observed at location 6 (Table 5) at step 11. This is earlier than anticipated however this disparity may be attributed to small variations in the gap size between the linings and the top floor. Figure 16b shows that the rotation was predominantly fully recovered at equilibrium until larger displacement cycles.

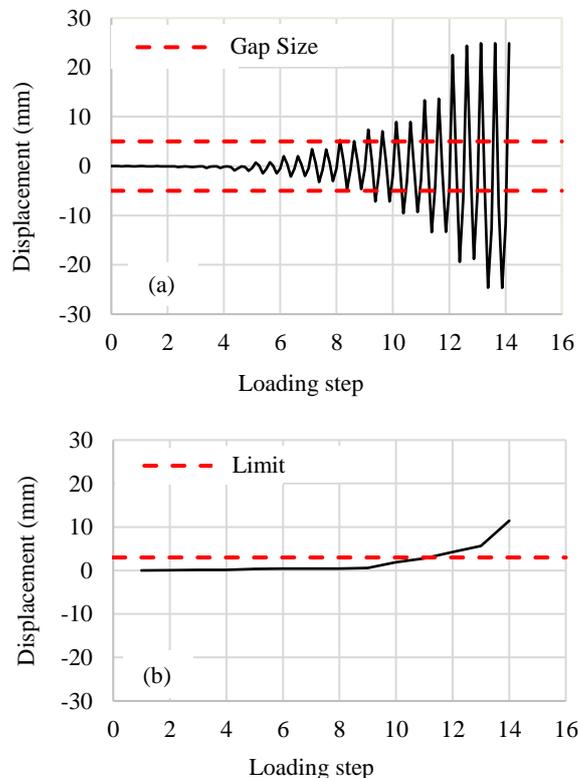
**Figure 17: Specimen 1 potentiometer readings to record sliding: (a) peak excursions during each step and (b) residual displacement after each step.**

(5) The residual gap size developing at the junction between the main wall and the returns was recorded. Figure 17a and 18a show the sliding of the linings during each cycle and Figure 17b and 18b show the residual sliding displacement of the linings at the end each cycle. For specimen 1, Figure 17b shows that the residual gap exceeded the limiting size for fire performance after step 11, and for specimen 2, Figure 18b indicates that there was negligible residual sliding and thus a residual gap should not have developed. However, it was observed that the bottom track within the North West return wall (location 7) had bent

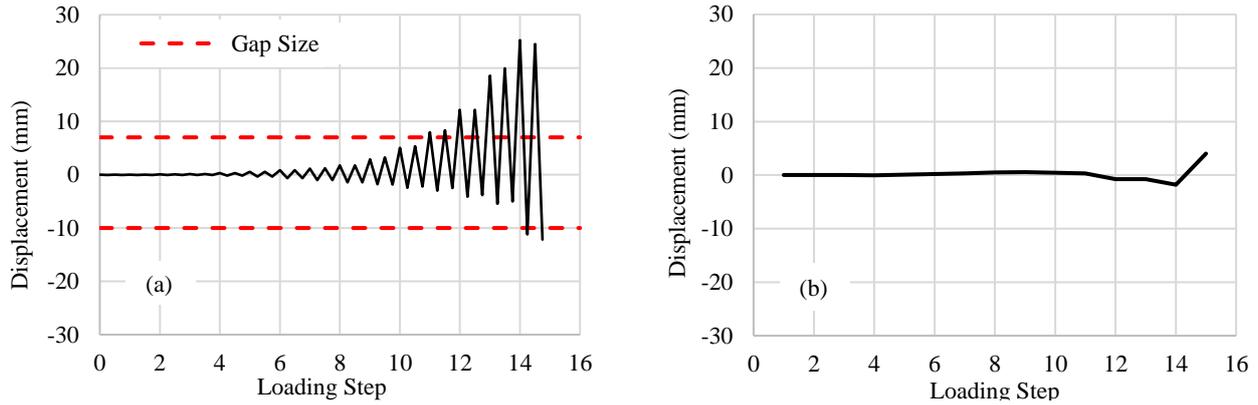
Figure 18: Specimen 2 potentiometer readings to record sliding: (a) peak excursions during each step and (b) residual displacement after each step.

such that at loading step 14 a residual gap was present even though the wallboards had returned to their original position as shown by Figure 18b. It can be seen in Figure 18 that the sliding of the linings occurred primarily in the positive direction. This is attributed to the bending of the bottom track at location 7, which will have reduced the sliding force imposed upon the linings when displaced in the negative direction.

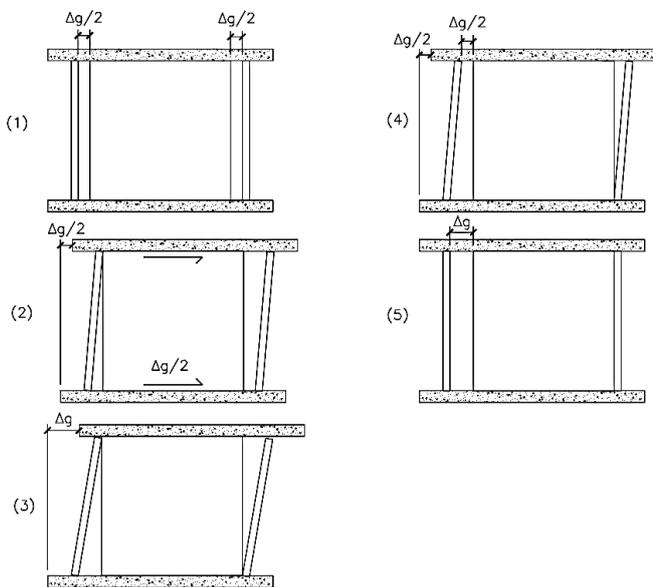
Figure 19: Explanation of residual gap formation for a loading sequence of one peak excursion: (1) Initial condition, (2) lateral displacement of  $\Delta g/2$  imposed on slab and gap on left closes, (3) lateral displacement of  $\Delta g$  imposed on slab, linings slide  $\Delta g/2$ , and gap on right also closes, (4) lateral displacement of slab reduced back to  $\Delta g/2$ , (5) lateral displacement of slab reduced to zero and residual displacement in wall remains.

Assuming both the return walls and the primary wall behave as rigid bodies, a gap forms at the junction of the main wall and return wall as explained in Figure 19 for specimen 1. This mechanism shows that the linings and studs slide as the gaps on either side of the wall close. However, when the relative displacement returns to equilibrium, they will not re-centre. The sliding of the main wall section was recorded by potentiometers. It can be seen in Figure 17a that at loading step 9, which corresponds to 0.48% drift and a displacement of 11.5 mm, the wall slides approximately half of the total gap size (5mm) in each direction. This is how the wall would be expected to behave if Figure 18 is a correct explanation; however, Figure 17b shows that the gap re-centres after step 9, and only begins to increase in size at larger cycles, until at step 11, corresponding to 0.94% in-plane drift, the gap is large enough such that the fire performance is hindered. This initial re-centring behaviour may be attributed to the presence of the gap filling material at the junctions. This is supported by the observation that separation of the gap filling material occurs at step 9 after which a gap begins to develop. Two solutions are possible to address the problem of residual gap development: (1) provide additional vertical strips of gypsum lining between adjacent walls and the vertical steel tracks such that a larger gap can be accommodated before the fire performance is hindered or (2) provide a pivot point to force the linings to return to their original position at the end of a loading cycle. The anticipated effect of introducing a pivot to the system is shown and explained in Figure 20.

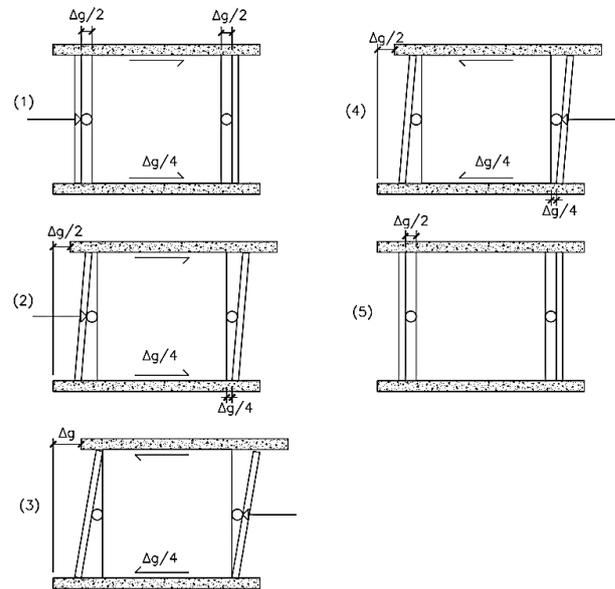
Figure 20: Explanation of the effects of introducing a pivot at mid-height on the formation of a residual gap, for a loading sequence of one peak excursion: (1) Initial condition, (2) lateral displacement of  $\Delta g/2$  imposed on slab and linings slide  $\Delta g/4$ , (3) lateral displacement of  $\Delta g$  imposed on slab and linings slide  $\Delta g/4$ , (4) lateral displacement of slab reduced back to  $\Delta g/2$  and linings slide back  $\Delta g/4$ , (5) lateral displacement of slab reduced to zero and residual linings slide  $\Delta g/4$  to return to initial position.

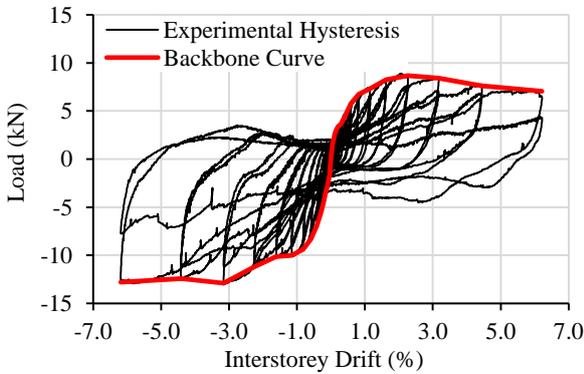
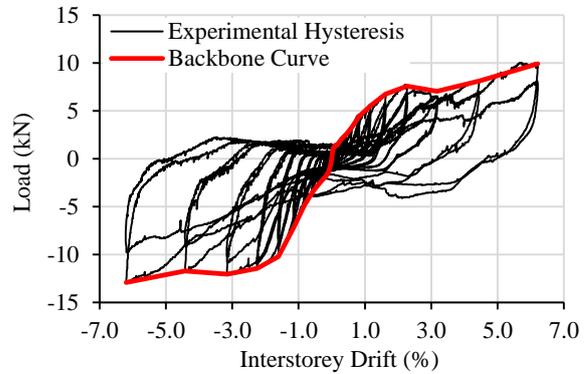
Figure 21: Left: Specimen 1 hysteresis; Right: Specimen 2 hysteresis.

The hysteretic response for the specimens is shown in Figure 21 and the maximum loads presented in Table 7. The general

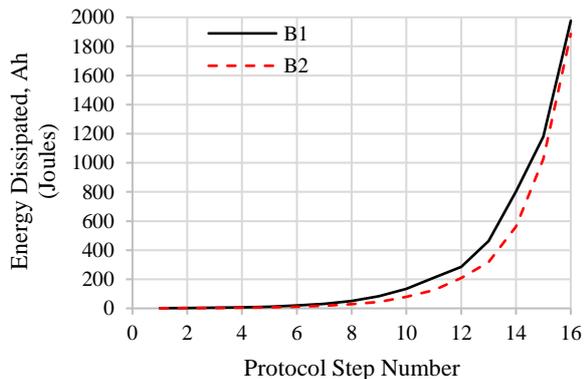
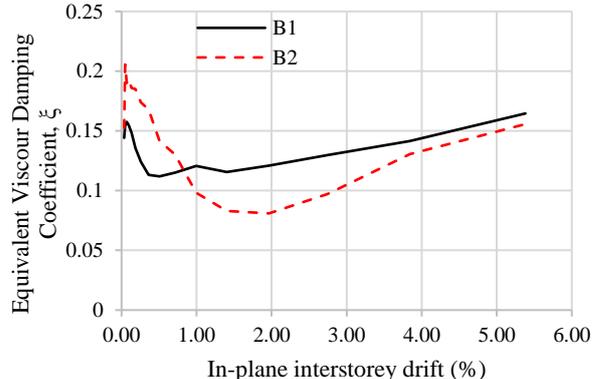
Figure 22: Left: Energy dissipation at each amplitude of loading; Right: Equivalent viscous damping coefficient (Equation 3).

The dissipated energy and equivalent viscous damping at each amplitude of loading was determined. This information may be useful for those interested in undertaking refined analyses on partition walls. The energy absorbed by the specimen is defined as the area within the force-displacement curve. The hysteretic curves shown in Figures 21a and 21b were integrated using the trapezium method for each increment in data. The energy dissipated in the two cycles of loading was averaged to attain the average energy dissipation at each amplitude. The equivalent viscous damping was determined at each cycle according to equation 3. Where  $A_h$  is the area within the hysteretic loop,  $F_m$  is the force at the displacement of  $\Delta_m$ , the maximum imposed displacement in the cycle. Applying this equation led to the values in Figure 22.
