ASSESSING WELLINGTON WATER'S PIPE CONDITION DATA CAPTURE

26 July 2023

A report developed for the Building Innovation Partnership at the University of Canterbury and Wellington Water by Cedric Papion, Stantec.

Assessing Wellington Water's Pipe condition data capture

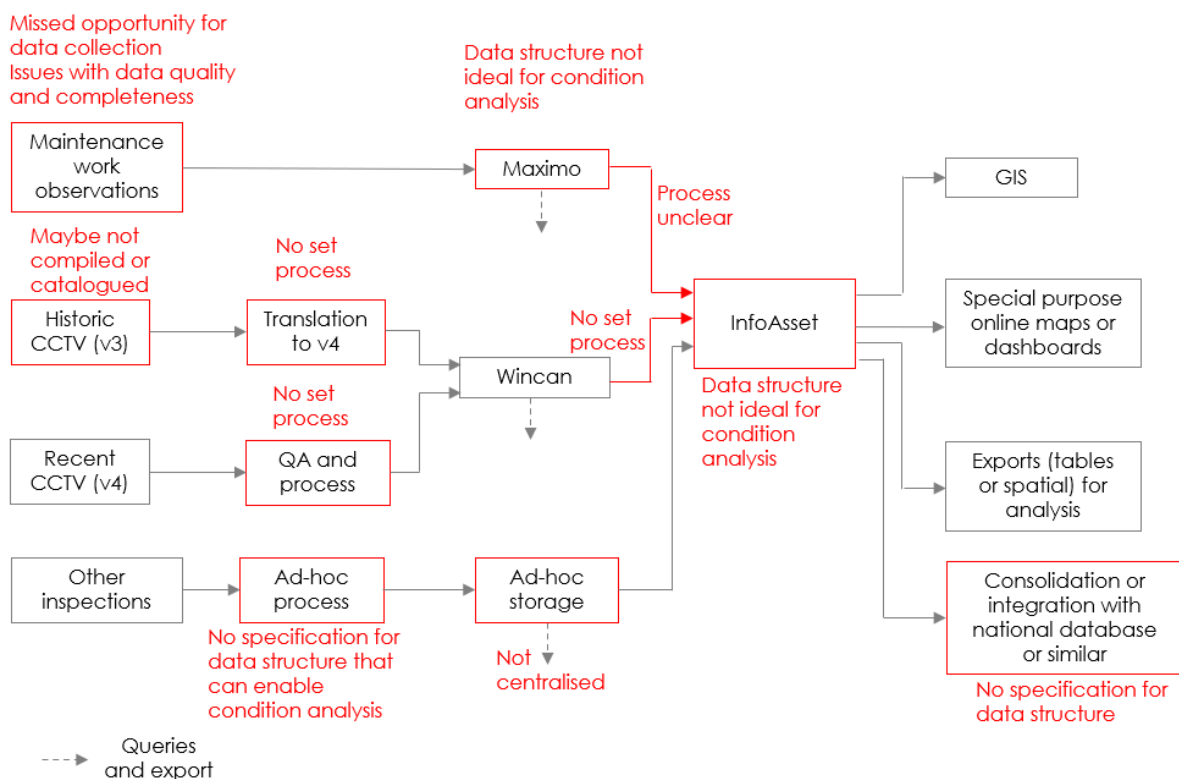
Figure 0-1: Pipe condition data map and summary of issues

Figure 0-1 summarises the issues identified. Table 0-1 captures the same information in a table format, along with options for consideration.

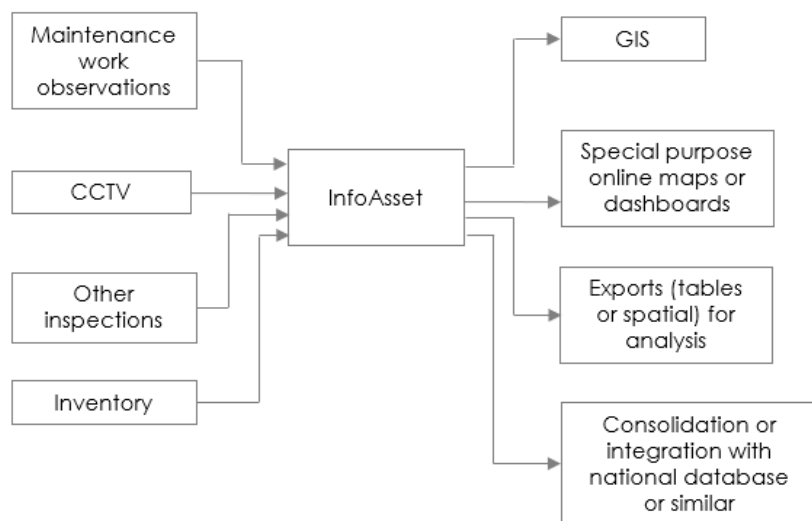
Figure 1-1: Simplified schematic of pipe condition data sources and uses

Maintenance work requires field staff to access the asset and this is seen as a missed opportunity to capture asset data, beyond the requirement of the maintenance activity.

While data collected across the local networks is the most pertinent, it can be augmented by data collected across the country. This can support inferences and predictions of asset condition but requires some consistency in data collection methods and the definition of the terms used. The Building Innovation Partnership (BIP), based at the University of Canterbury, is working toward a national water pipe failure database to assist with the sharing of this information.

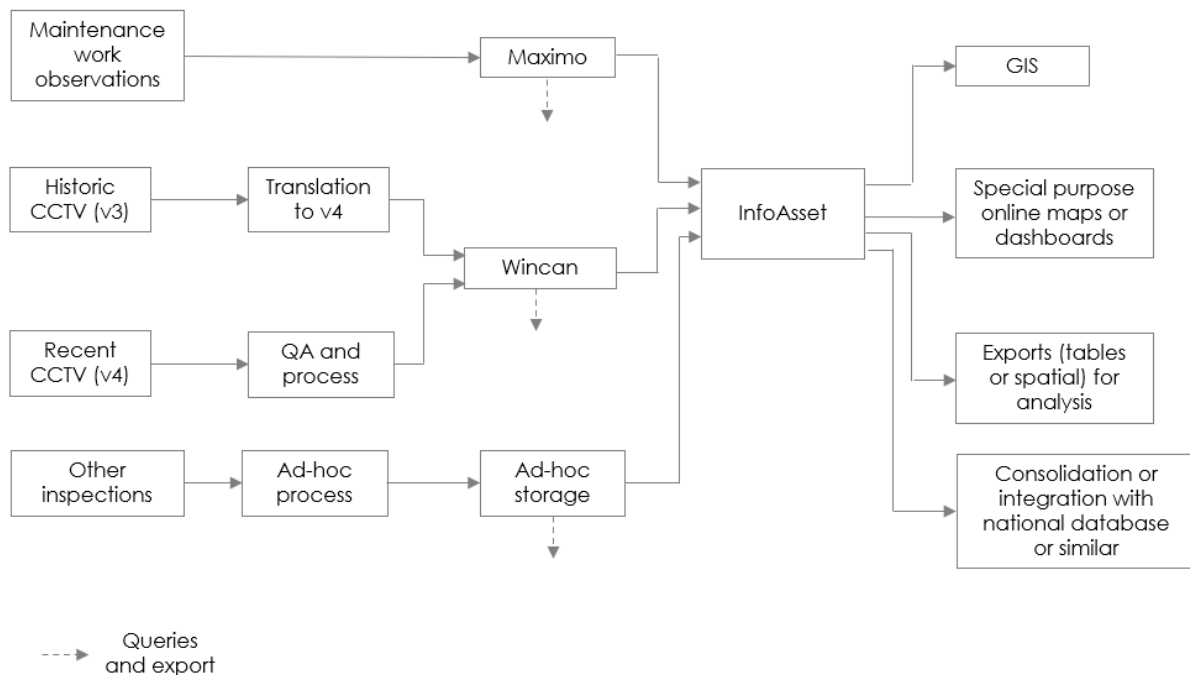
The current vision is that all condition data (factors, defects, failures) should be centralised in InfoAsset, possibly with links to attachments such as videos on Wincan or maintenance details in Maximo. From InfoAsset, the data should be passed to GIS, dedicated online maps, dashboards, one-off queries for condition studies and higher-level systems such as a national pipe failure database or similar.

Figure 4-2: Current vision for data pertaining to pipe condition factors, defects and failure

Finally, it may be worthwhile challenging the current data flow path as outlined in Figure 4-2. For example, it may be possible and beneficial to push data directly from field observations to InfoAsset (or similar), thus bypassing Maximo - Maximo would still remain as the COG maintenance activities system.

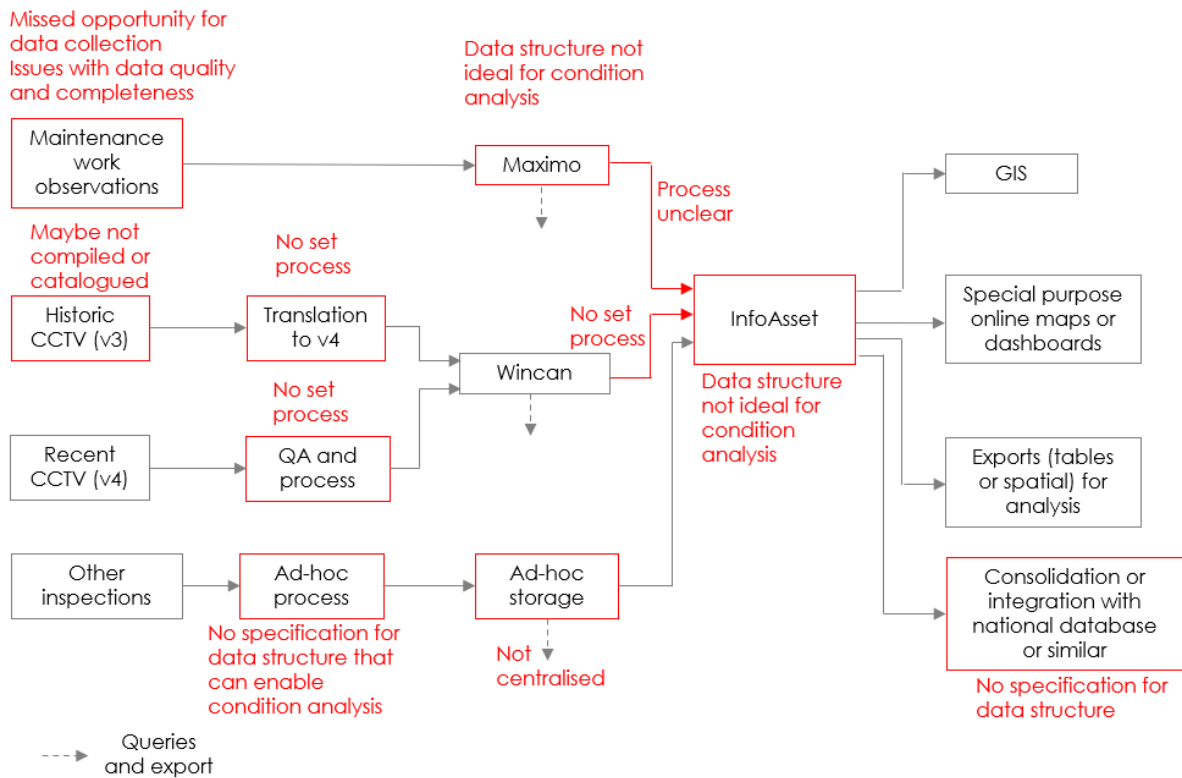
Figure 5-1: Summary of issues

Figure 5-1 summarises the issues mentioned throughout the report. Table 5-1 captures the same information in a table format, along with options for consideration.
